# STRUCTURAL FAILURES

## Snow Load Collapse of a Manufacturing Building in Oregon

By Dilip Khatri, Ph.D., S.E.

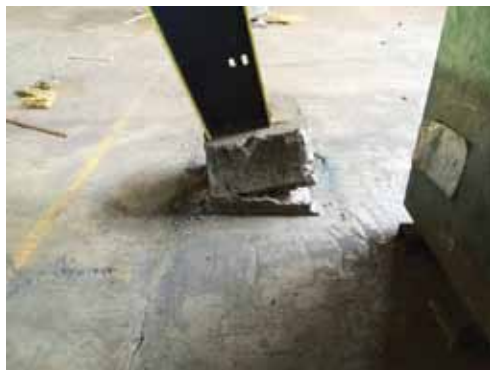
Figure 2.

of this steel moment frame facility to collapse. Fortunately, this failure occurred in the early hours of the morning and no fatalities were experienced. *Figures 1 through 5* show the extent of the damage and loss of inventory. The building was constructed in the 1940s and comprises approximately 400,000 square feet of space, which was designed through successive permits over several decades. In its entirety, the design of this facility ranges from the 1940s-1960s vintage, and remained in operation until the 2014 storm event.

As can be observed from *Figures 1 through 5*, and after doing a collapse load analysis, the reasons for the failure are attributed to several causes:

- 1) Excessive snow/ice loading due the storm event that exceeded the capacity of the steel moment frame system.
- 2) Plastic Hinge Failure at several locations in the steel moment frame system, including compression flange failure of the top chord of the truss.
- 3) Footing failure at the base reaction.

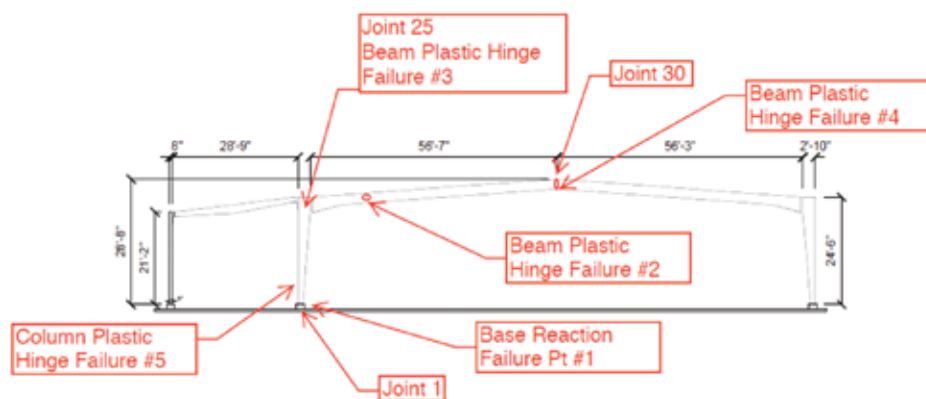
Figure 6.

can move in three translational directions (x,y,z) and this is very difficult to determine with crude measurement devices such as a plumb bob, laser level, or visual means. The alignment survey of this facility showed certain frames had serious misalignment issues that render them potentially unsafe. This was further compounded by the fact that the collapse load analysis showed the failure deflection was less than 2 to 3 inches on certain moment frames. A low collapse load capacity, which translates into a low deflection tolerance, means that these structural frames are a collapse hazard in storm events and must be retrofitted/repared.
